## Tsubaki Advantage Success Story

| <b>Application No.:</b> | <a href="#">5993</a> |
| <b>Application Name:</b> | Chip Conveyor Chain 550-551 |

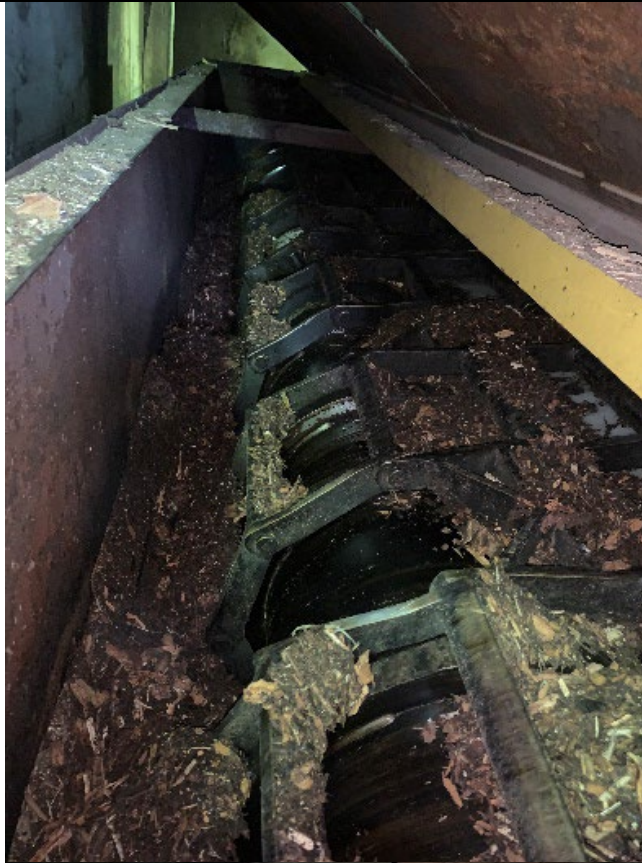
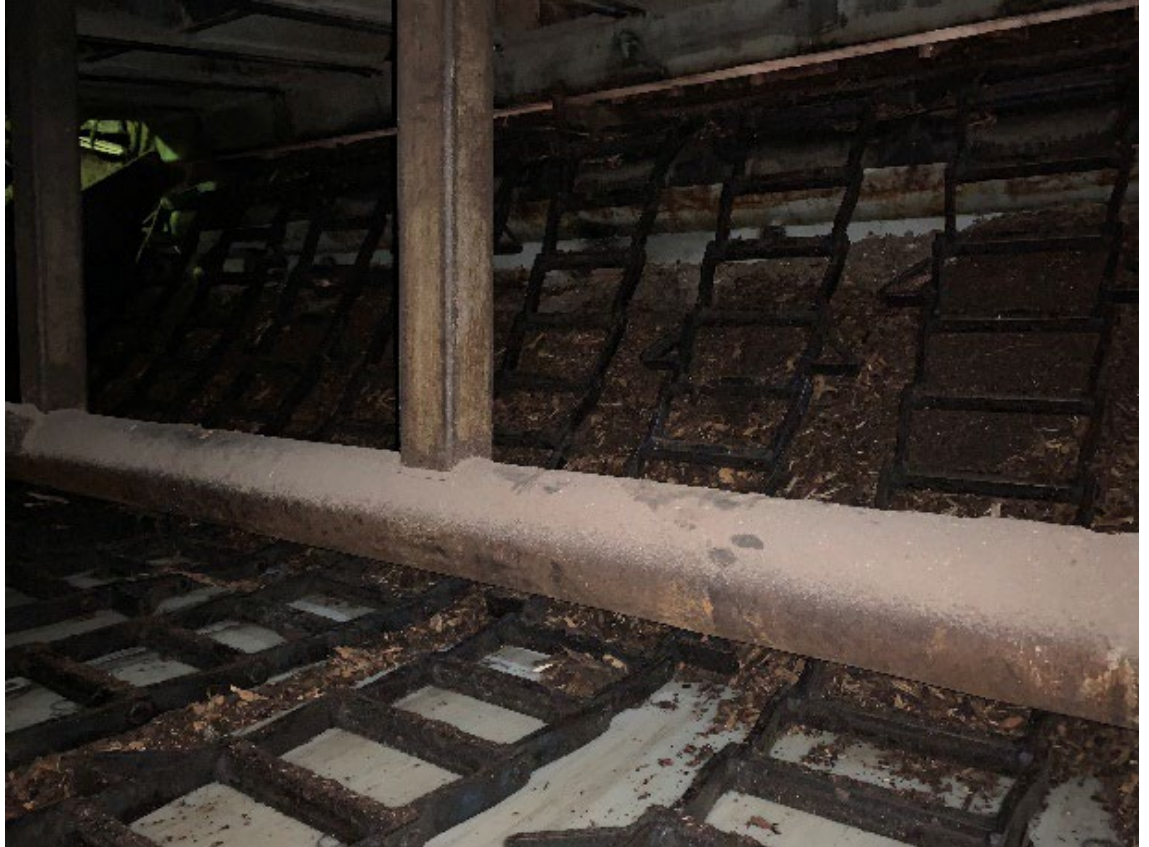
| <b>Issue:</b> | Attachment weld cracking |
| <b>Tsubaki Solution:</b> | Customer was experiencing attachment failure due to poor weld quality on the original chain. A22 attachments are welded to the middle of the sidebar and would break off during operation. Tsubaki's licensed welders applied proper pre-heat, welding, and cool-down processes to ensure there would be no attachment failures in the field. |
