## SUCCESS STORY

# Elongation on a Chocolate Forming Line

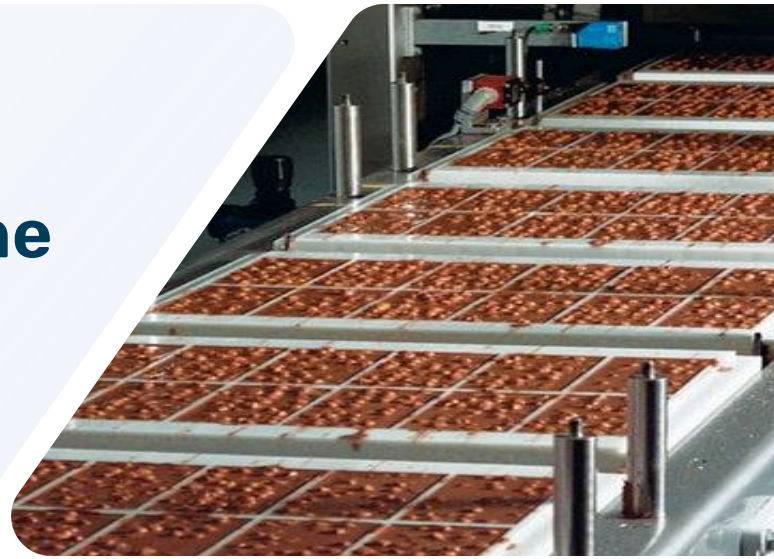
A customer was using two strands of the original equipment manufacturer's RS100 narrow chain with threaded pins that hold the trays used to mould liquid chocolate. An issue arose with elongation due to poor lubrication and pin breakage.

Tsubaki's experts recommended the **RS100 narrow Lambda chain** with an integral pin design. The Lambda chain solved the poor lubrication issue, and the new pin design resolved the pin breakage.

While the original chain lasted five years with downtime and resources spent on preventative maintenance, Tsubaki's chain lasted six years with no breakages or lost production hours.
