SUCCESS STORY

Chain Wear While Moving Raw Synthetic Gypsum

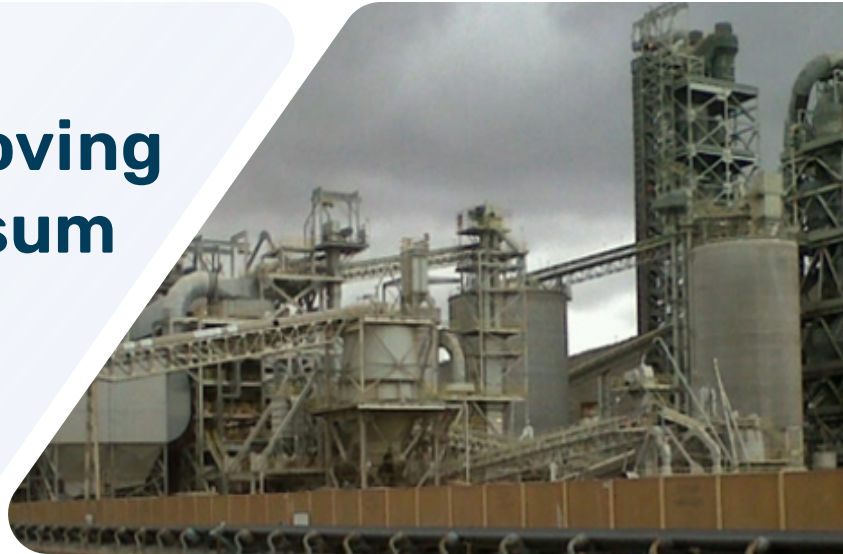
Our Technical Solutions Team recommended hardened stainless-steel pins and bushings along with extended bushings through the inner sidebars with nitride seals (SJ2) on the ends of the extended bushings to help reduce corrosion and wear within critical areas. The **SJ2 technology** prevents the gypsum from getting into the pin-bushing area, increasing wear life.

A customer was having issues with a competitor's 4850 chain with G6 attachment. When moving raw synthetic gypsum via buckets to the next process area, gypsum would get into the pin and bushing area, triggering the pin to wear, causing the competitor's chain to last for only two years.

While the cost of the new chain is more than twice as much as the competitor's chain, it's been running for more than four years, leading to long-term cost savings. To date, Tsubaki's chain shows no wear and elongation with all seals intact.
