SUCCESS STORY

Chain Failure on a Poultry Fryer

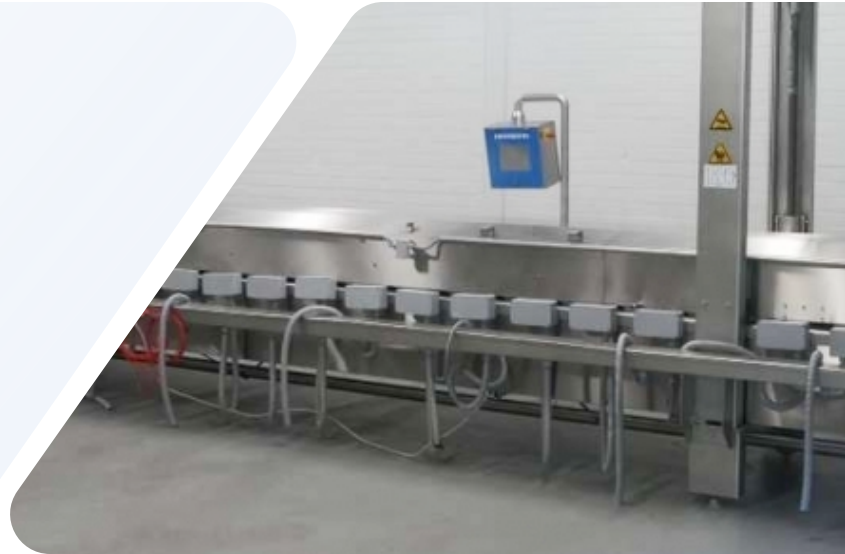
A well-known poultry processor was experiencing attachment chain failure in one of their fryers. The dual-strand chain runs in hot oil, scraping the coating residue from the conveyor, and has A1 type attachments and scraper bars every three feet. Periodically, the attachments would come out of alignment, causing the A1 attachment to break at the bend in the side plate.

After contacting Tsubaki for a solution, our **Technical Solutions Team** visited the site and conducted a thorough review of the application and discussed possible solutions with plant staff. Upon investigation, it was determined that the way the scraper bars were fastened to the A1 attachment created too ridged a structure and, when the attachments were out of alignment, the scraper bar created too much force on the side plate bend. Tsubaki suggested slotting the scraper bars to allow for “float” alongside several other application optimizations.

After implementing Tsubaki’s recommendations, the processor experienced significantly less unplanned downtime. Over a four-month period, unplanned downtime was reduced by 75% from 102 to 25 hours, correlating to a \$94,248 cost saving per year.
