SUCCESS STORY

Stone Elevator Sprocket with Wear Indicator

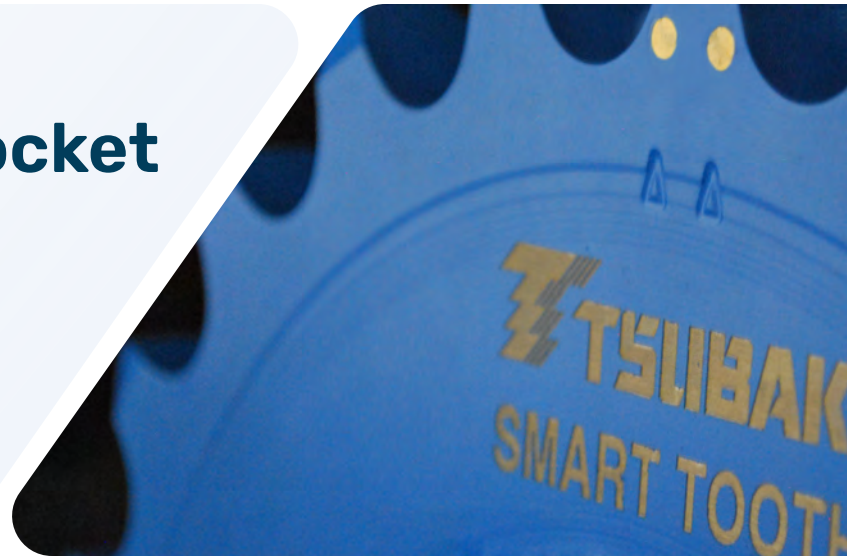
As recommended by the **Tsubaki Technical Solutions Team**, the customer decided to switch to Tsubaki's steel boot sprocket with **Smart Tooth® wear indicator** for their application. Wear indicators provide visual evidence that a sprocket is still within the allowable wear tolerance, and when replacement is required. Tsubaki's **Smart Tooth technology** suited this application perfectly – the customer managed to save on maintenance time and develop a better sprocket inspection process. Now, visual inspection is the only thing needed – no sprocket disassembly required.
