SUCCESS STORY

Conveyor Chain Corrosion

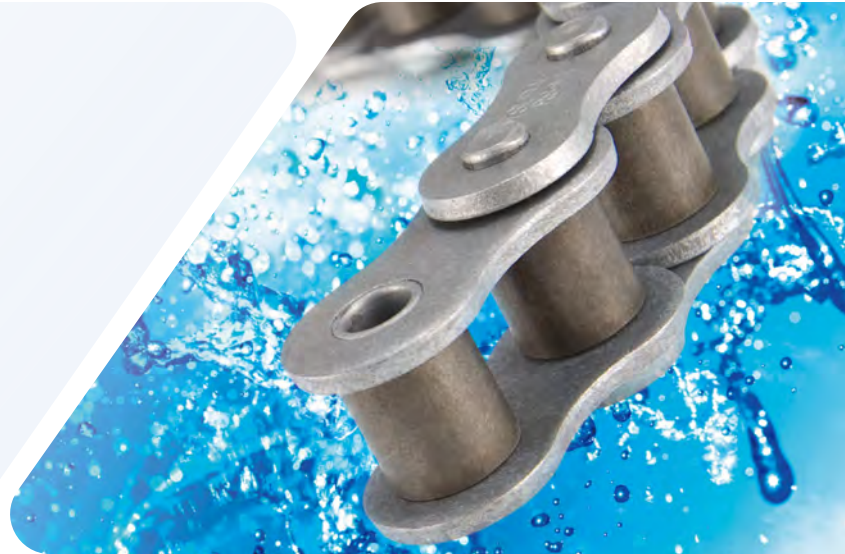
The RS60 double strand chain with extended pin attachments was sent to Tsubaki's Technical Solutions Team for inspection. While it was used on a vegetable packing line with no direct washdown, it was experiencing residual spray and showed significant signs of corrosion covering the link plates.

We also saw, when we disassembled and thoroughly inspected the chain, that the pin surface showed pitting corrosion, pin galling, and absence of lubrication between the pin and bushing.

The **Technical Solutions Team** recommended replacing the chain with a corrosion resistant **NEPTUNE series chain** with chrome hardened pins as an added feature. Doing so would prevent pin galling when lubrication is a challenge and extend its working life.
