SUCCESS STORY**Chain Issues in a Harsh Environment****\$6,900**

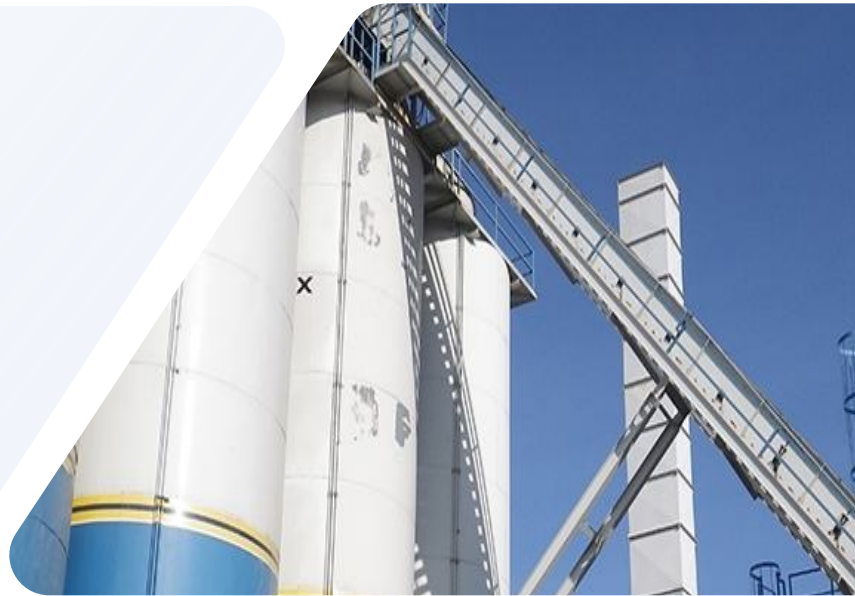
A concrete company was using a competitor's RS80 chain with homemade top rollers made from RS80-2 connecting links. Due to a harsh environment that involved dust, sand, and heat, the company could not properly lubricate the chain as the lubrication would cake up on the side plates, not reaching critical points. The chain lasted a total of six months.

Due to its added wear-resistant properties of the hard-chromed plated pins and quad riveted design, Tsubaki's Technical Solutions Team recommended Speed Master.

The solution enabled the chain to handle side impact better. The result was an additional 2.5 years of life with cost savings of almost \$7,000.
